What's the Risk?

Kitec Piping in Houses

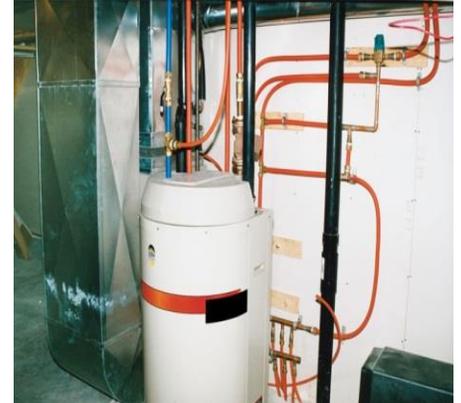
Kitec piping is the brand name of a domestic water piping system used for potable water lines and hot water heating systems in residential dwellings. This system was used between 1995 and 2007. Kitec was manufactured in Canada by Ipex Inc. under several different brand names. The Kitec plumbing system consisted of piping and fittings. The pipe is a thin layer of aluminum sandwiched between an inner and outer layer of Pex plastic. The fittings are made of brass, and the brass is composed of copper and Zinc.

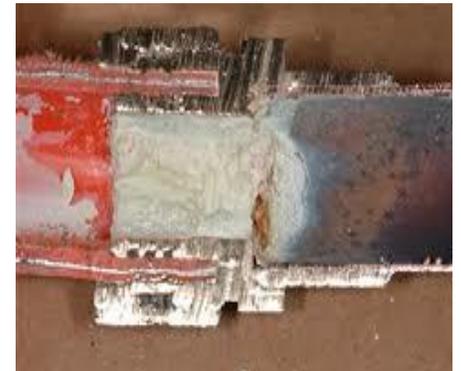
During the manufacturing process Ipex added an antioxidant to the Pex piping. This was done to prevent corrosion. It is believed the antioxidant resulted in the separation of the Pex layer and eventual corrosion of the aluminum core. This caused weakening of the pipe resulting in its premature failure in some cases. The fittings were also affected by a chemical reaction called Dezincification. Dezincification accelerates the corrosion of brass fittings as zinc leaches out of the fittings. The result is a weakening of the structural integrity of the brass causing the fittings to fail.

The only way to determine if a house has Kitec piping is to have a qualified plumber inspect the piping used in the house. If the plumber determines Kitec piping is being used, it must be replaced as soon as practicable by a qualified plumber. For more information, see the Kitec Settlement website at the following link: <http://www.kitecsettlement.com/faq.cfm>
